Situation Photo Log

Tuesday, July 3, 2012

Kalamazoo River / Enbridge Spill

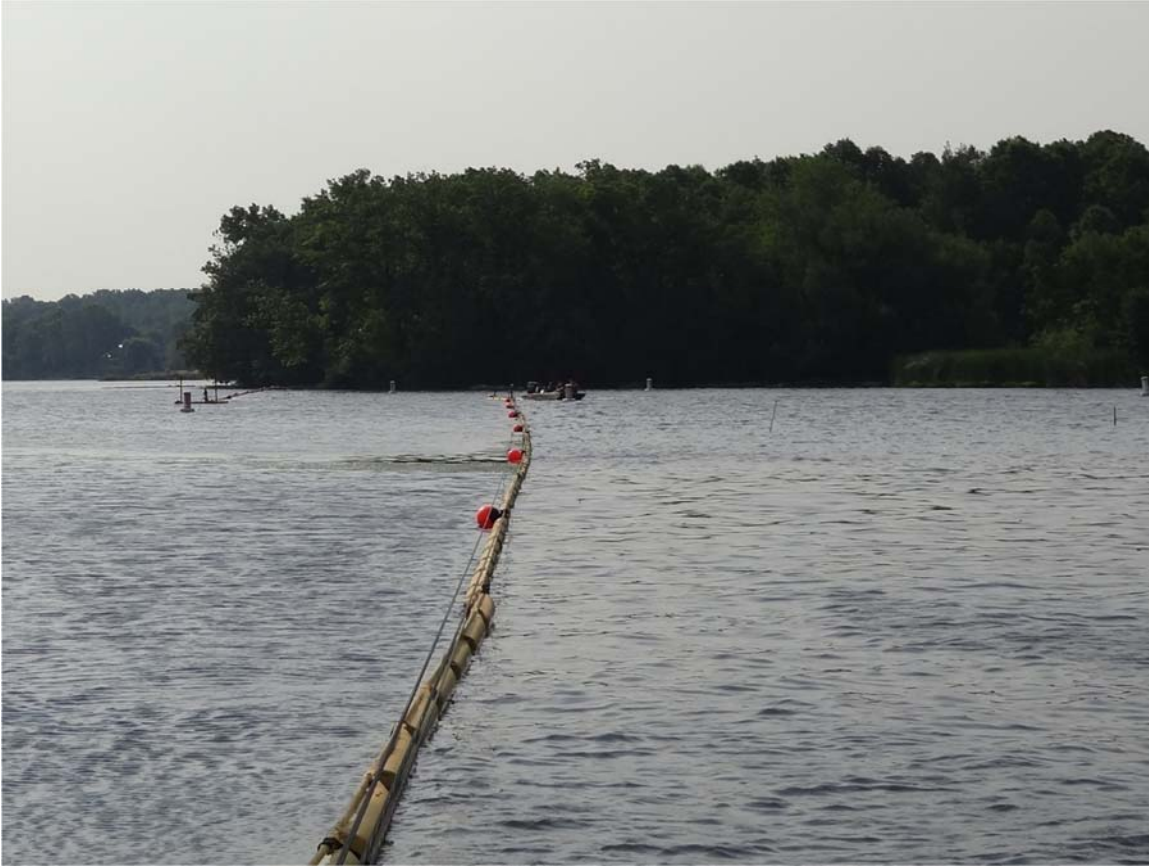
1. E4 Boom System observed crews inspecting the curtain with underwater cameras.

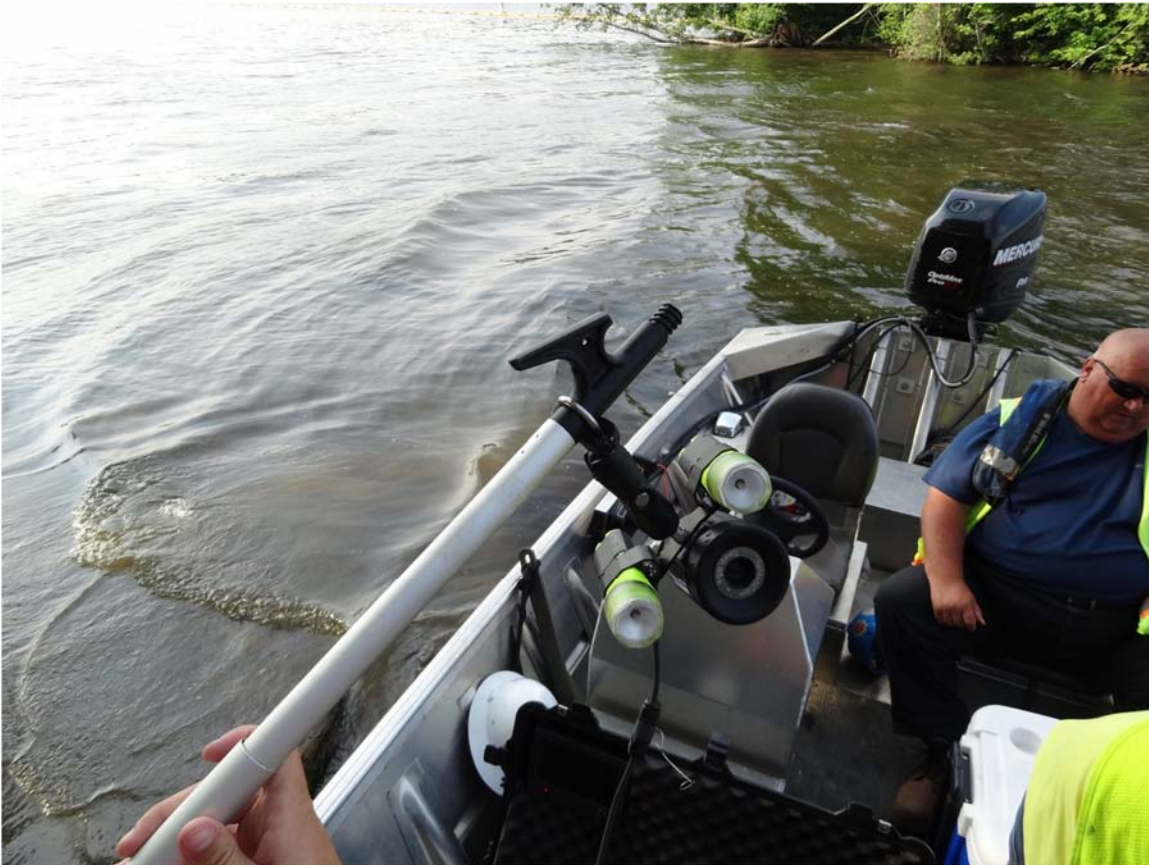
2. Underwater camera being utilized by US EPA.

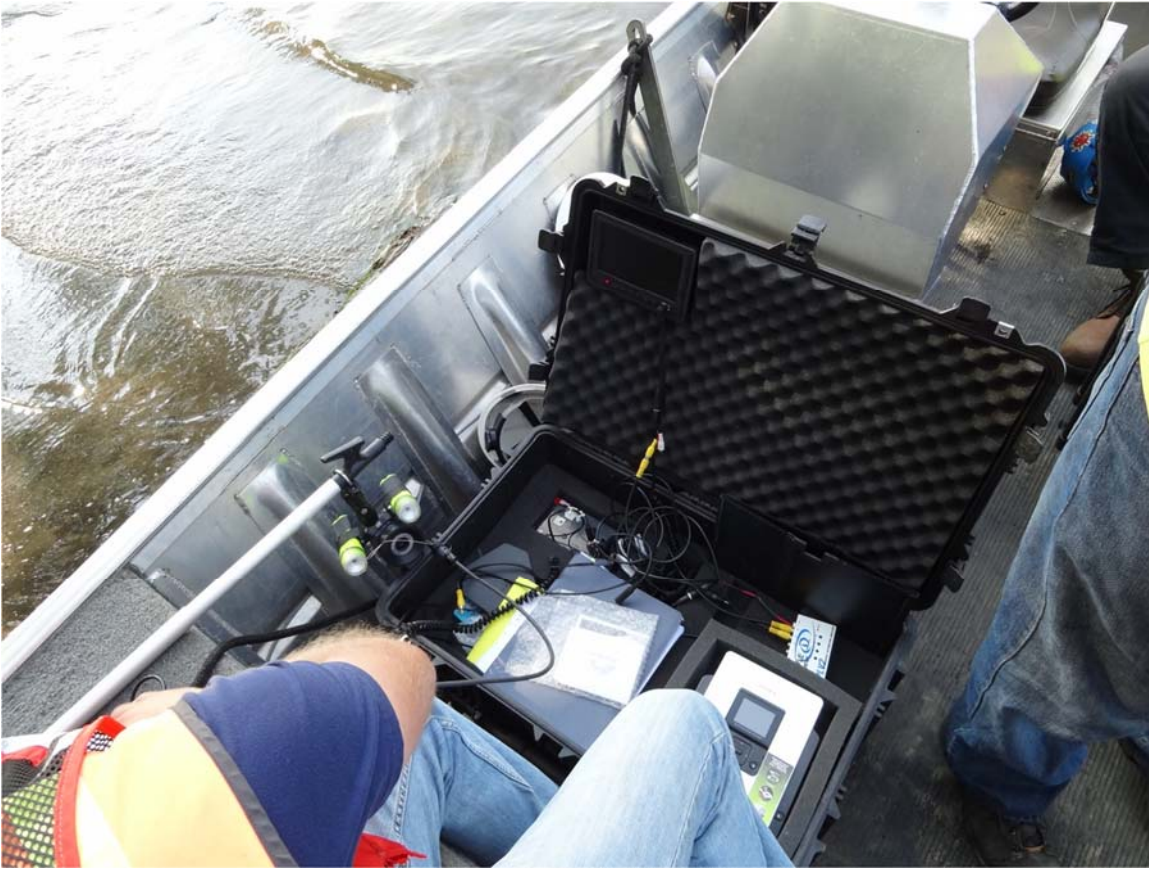
3. Underwater camera being utilized by US EPA.

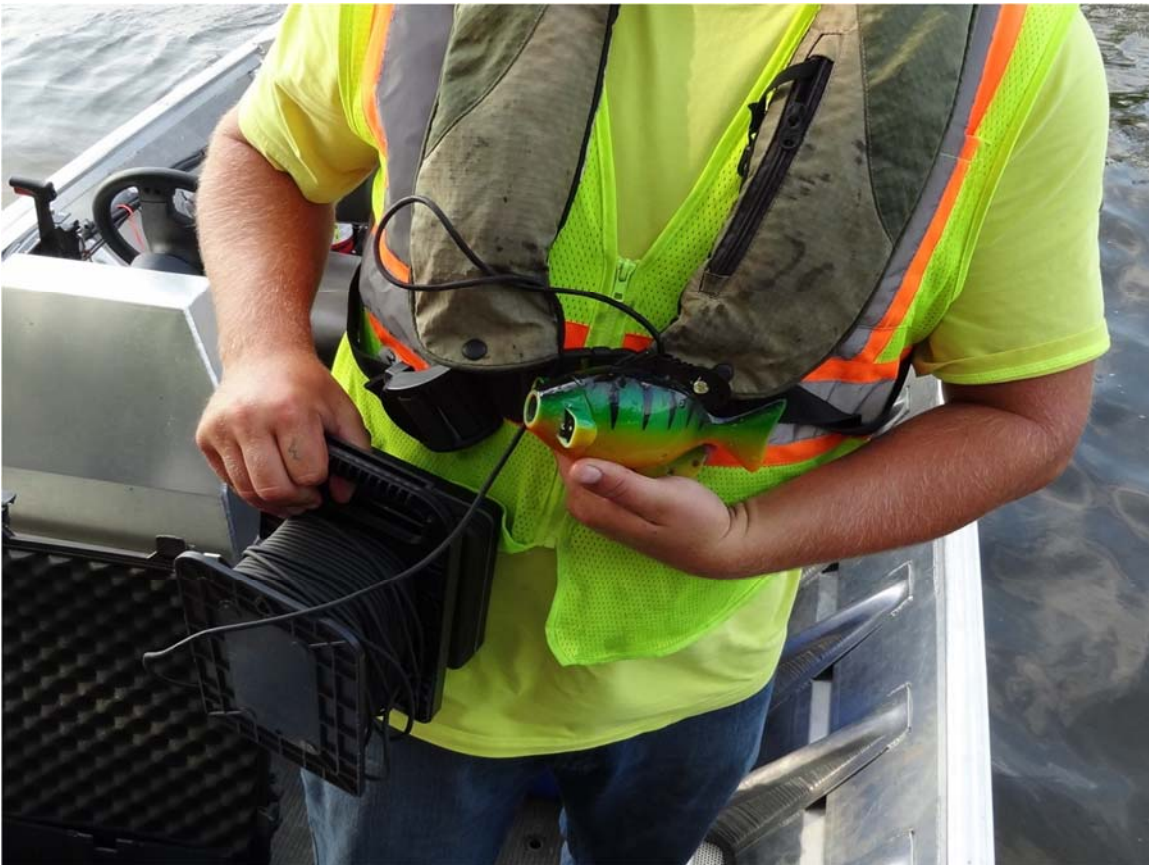
4. Underwater camera being utilized by Enbridge.

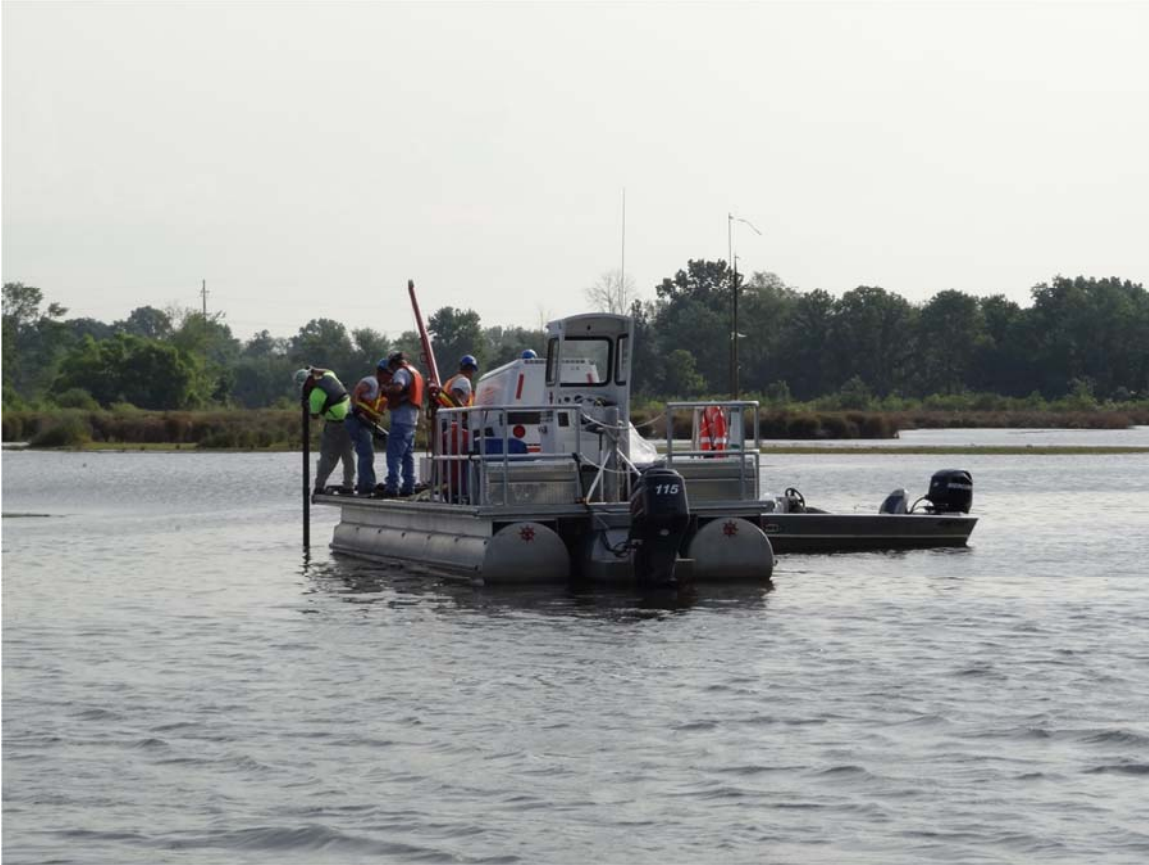
5. Morrow Lake Delta observed crew installing an anchor point for the E4 Boom System Boom A.

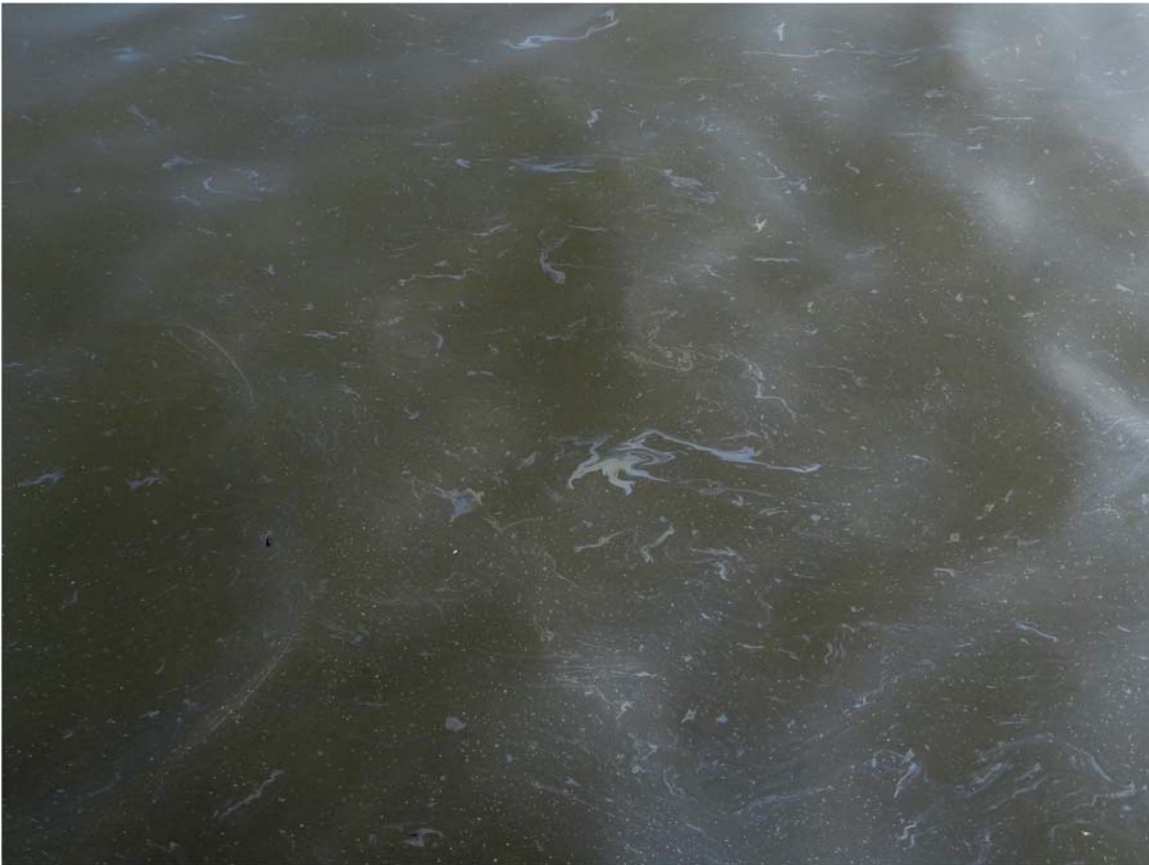
6. Sheen observed in the area of the pontoon barge operating in the Morrow Lake Delta.

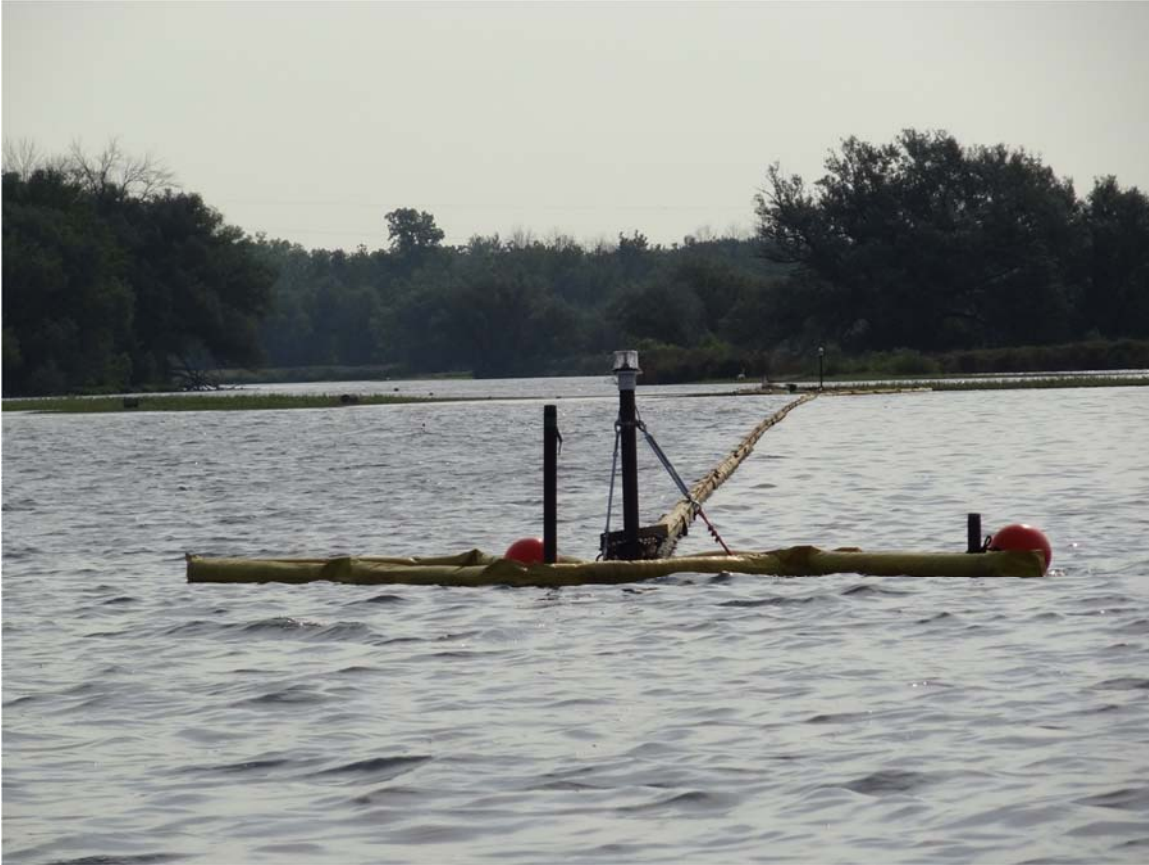
7. Observed a segment of the E4 Boom System Boom C partially installed.

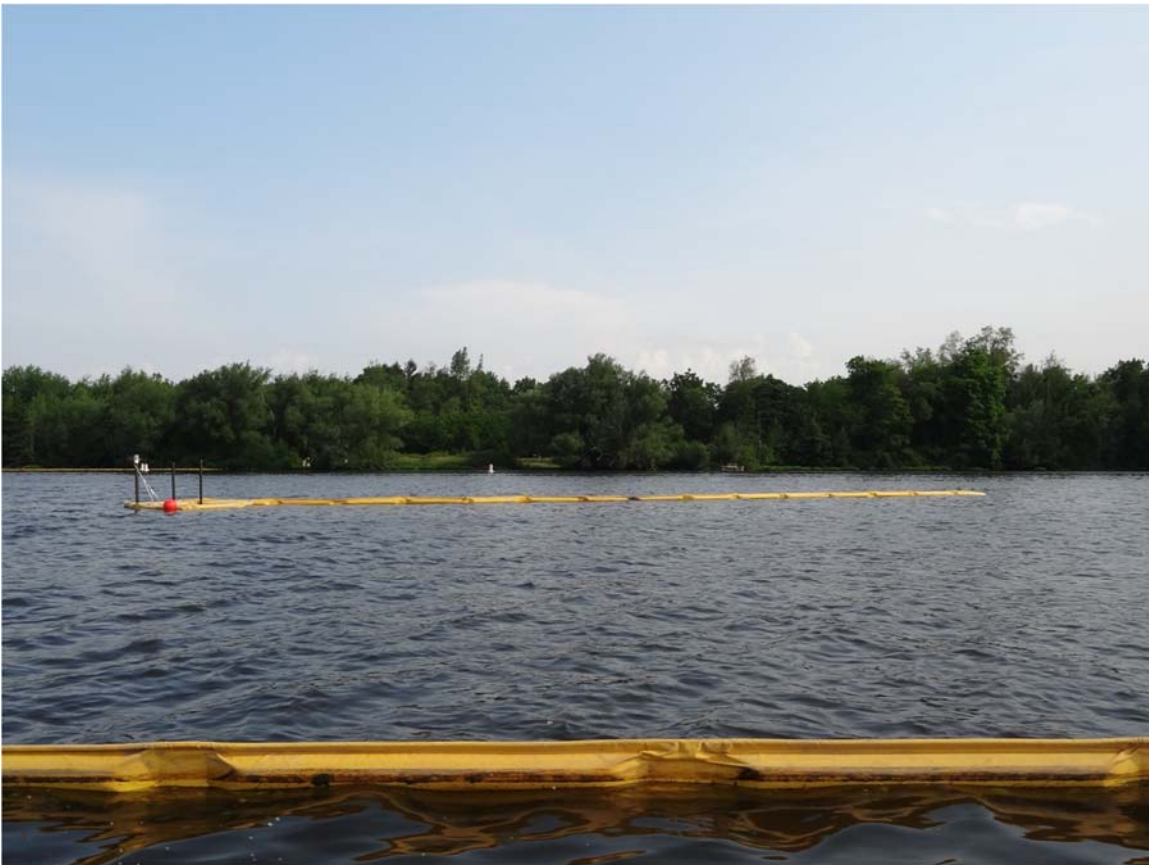
8. Observed a segment of the E4 Boom System Boom C partially installed.

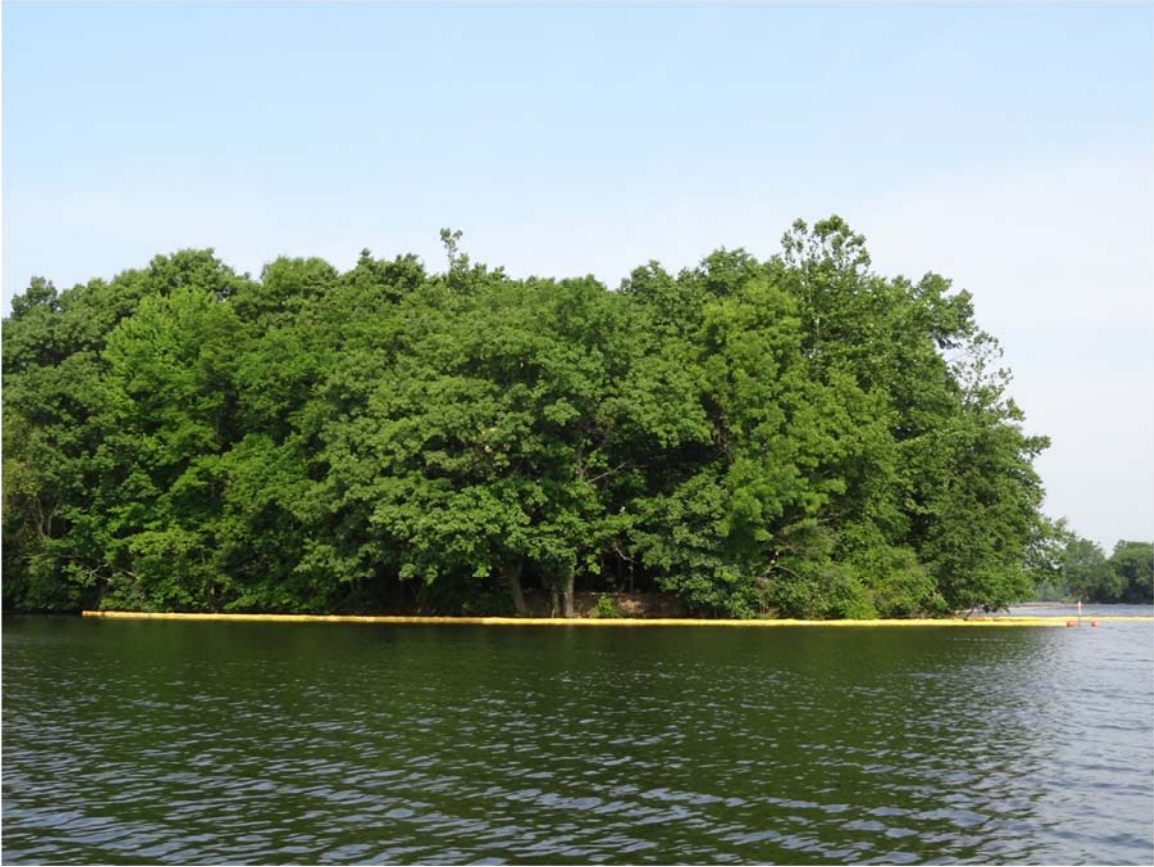
9. Observed a segment of the E4 Boom System Boom C partially installed.

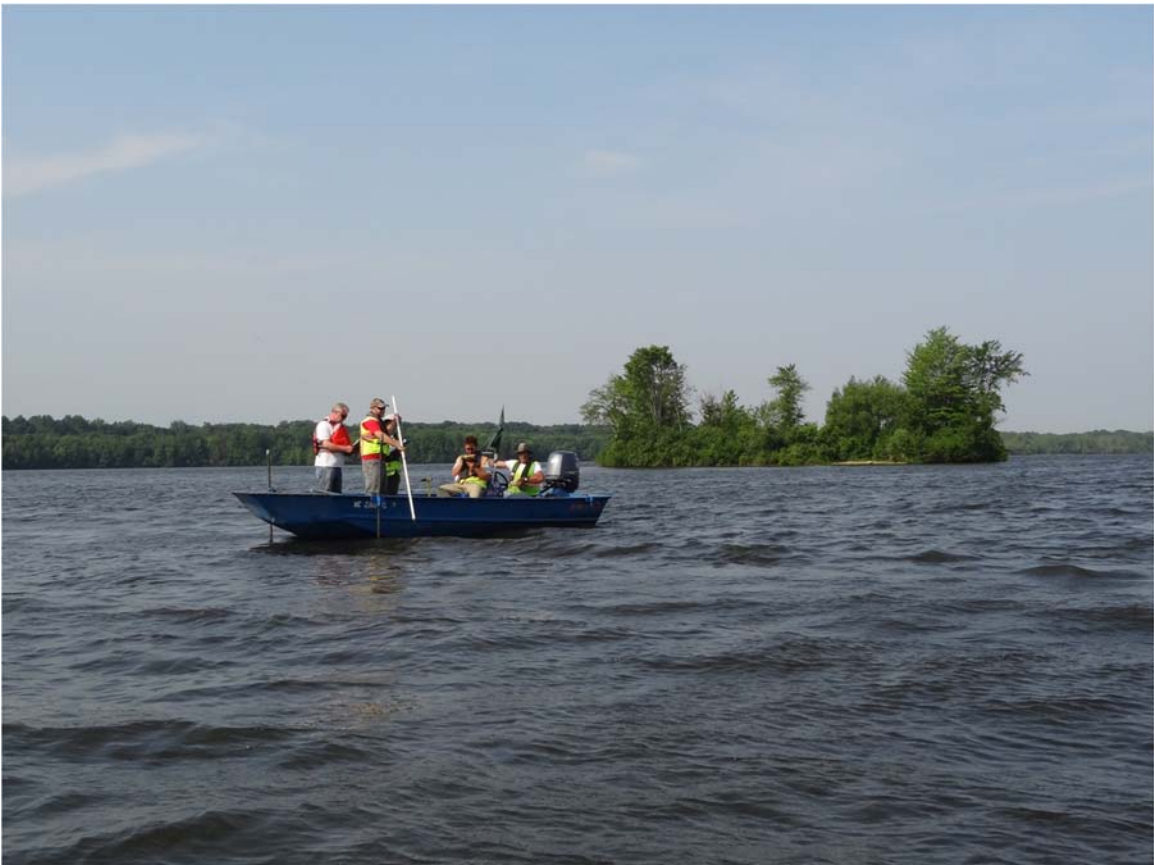
10. Morrow Lake poling crew observed.

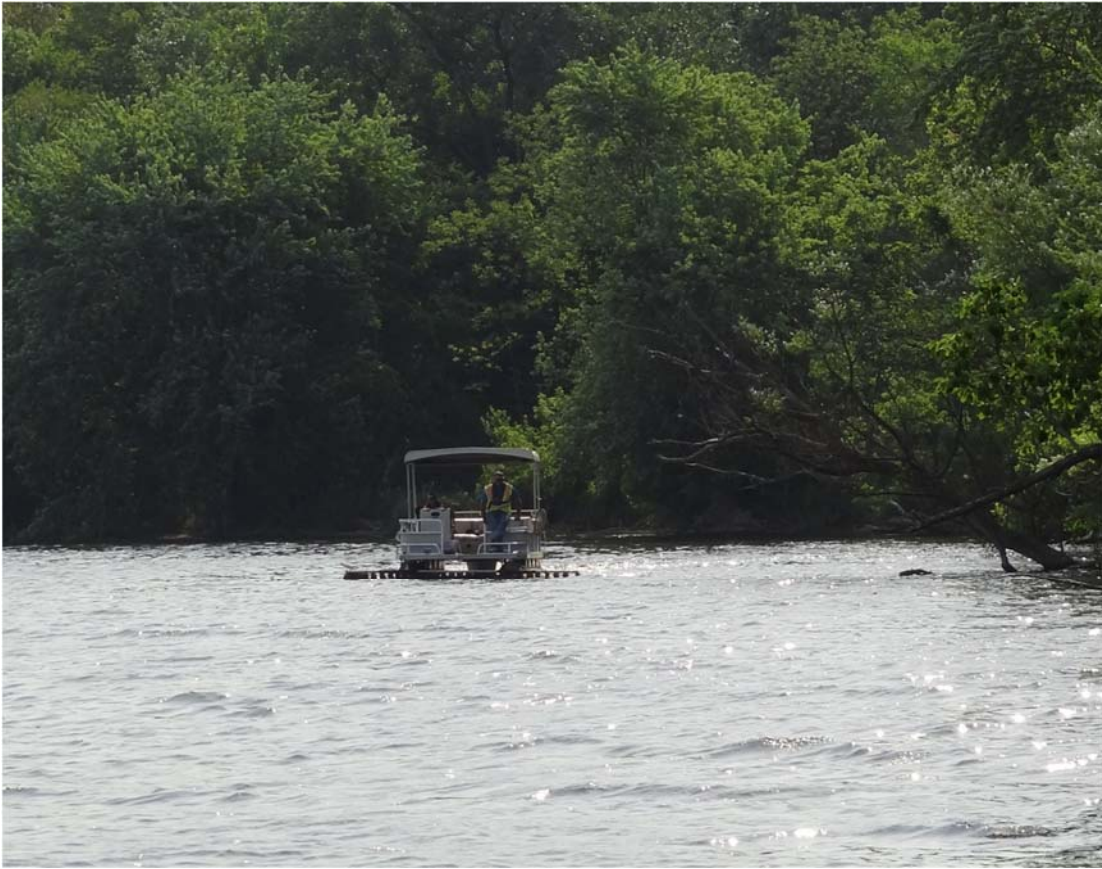
11. Morrow Lake observed the sheen sweep boat operating in the southeast cove of the lake.

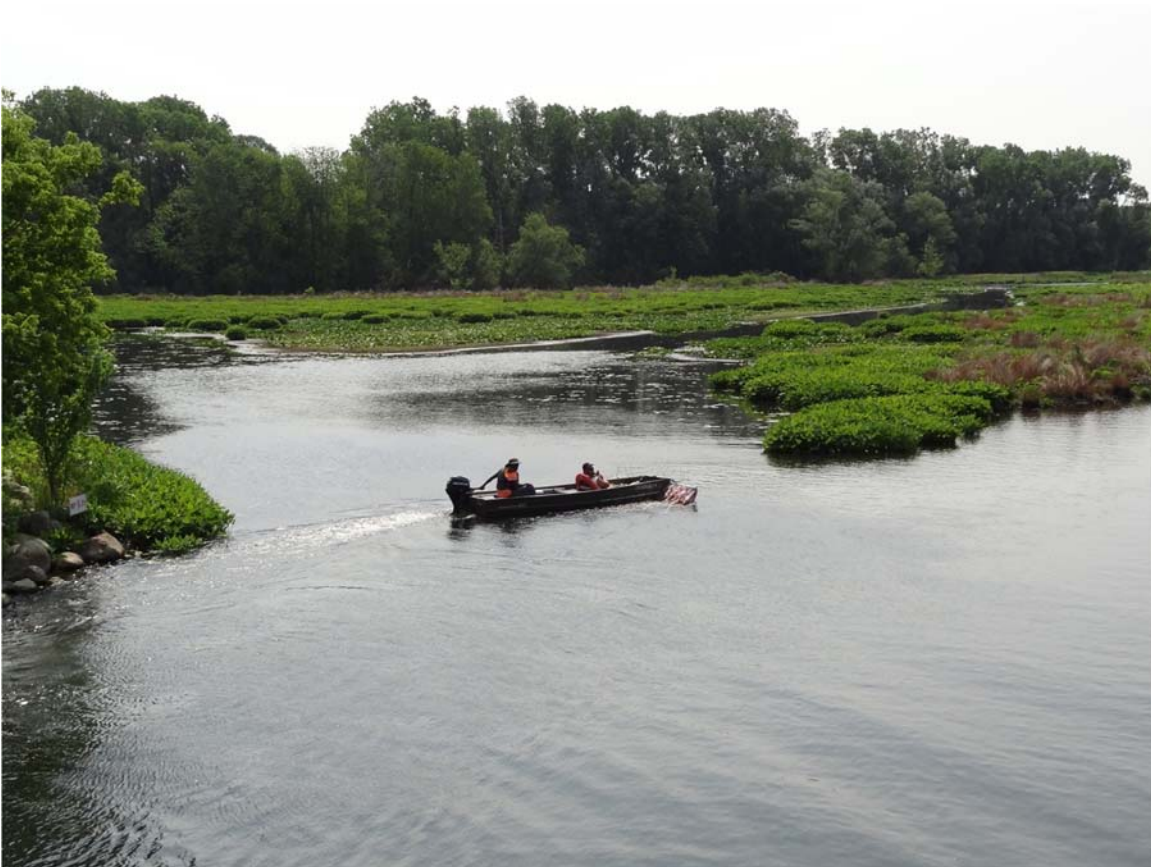
12. South Mill Pond observed sheen sweep boat operating.

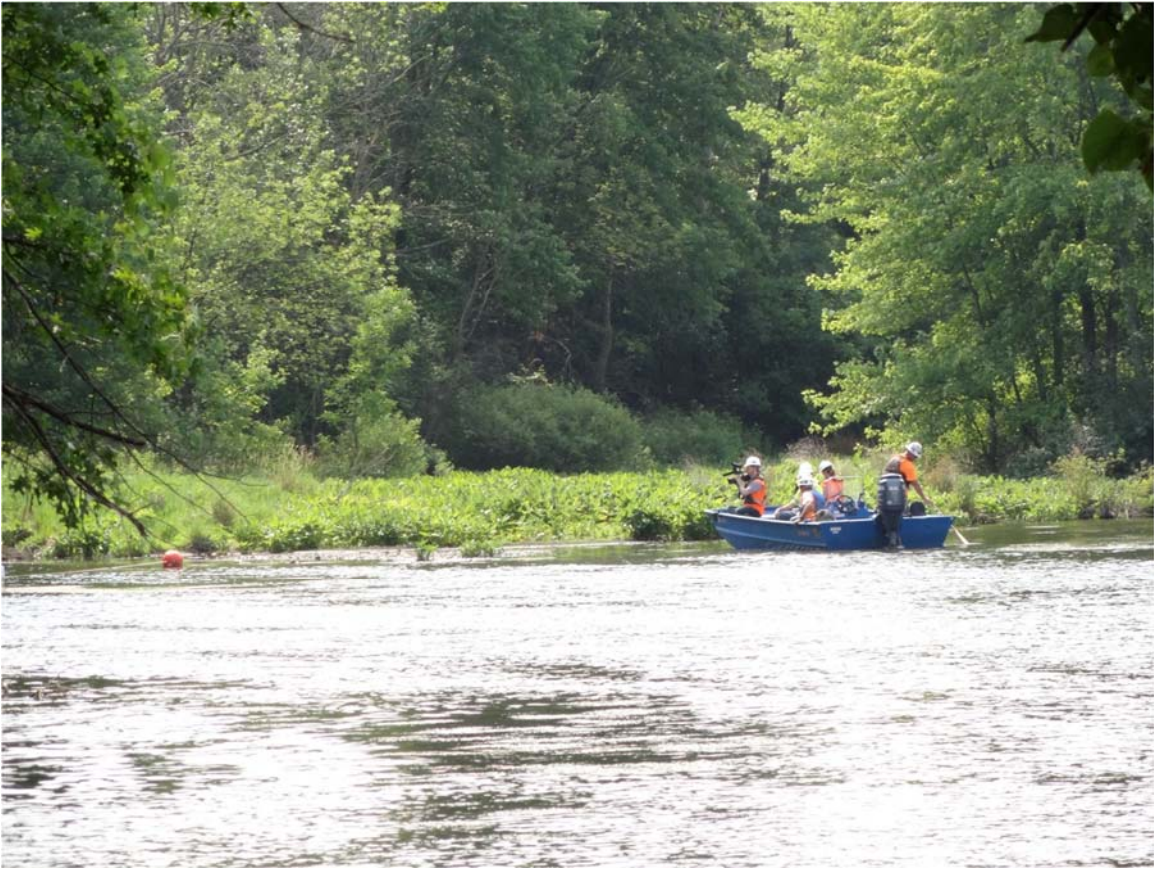
13. MP14.75 observed a media tour.

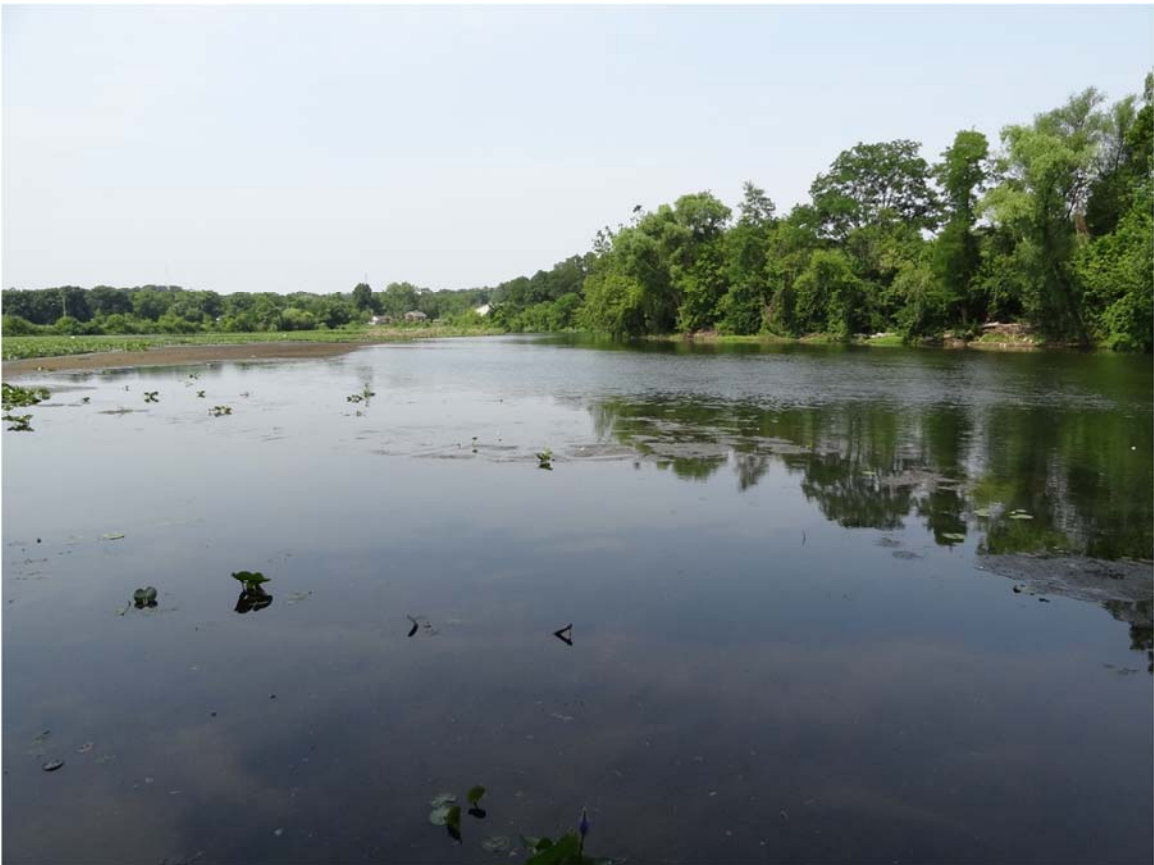
14. North Mill Pond observed sheen.

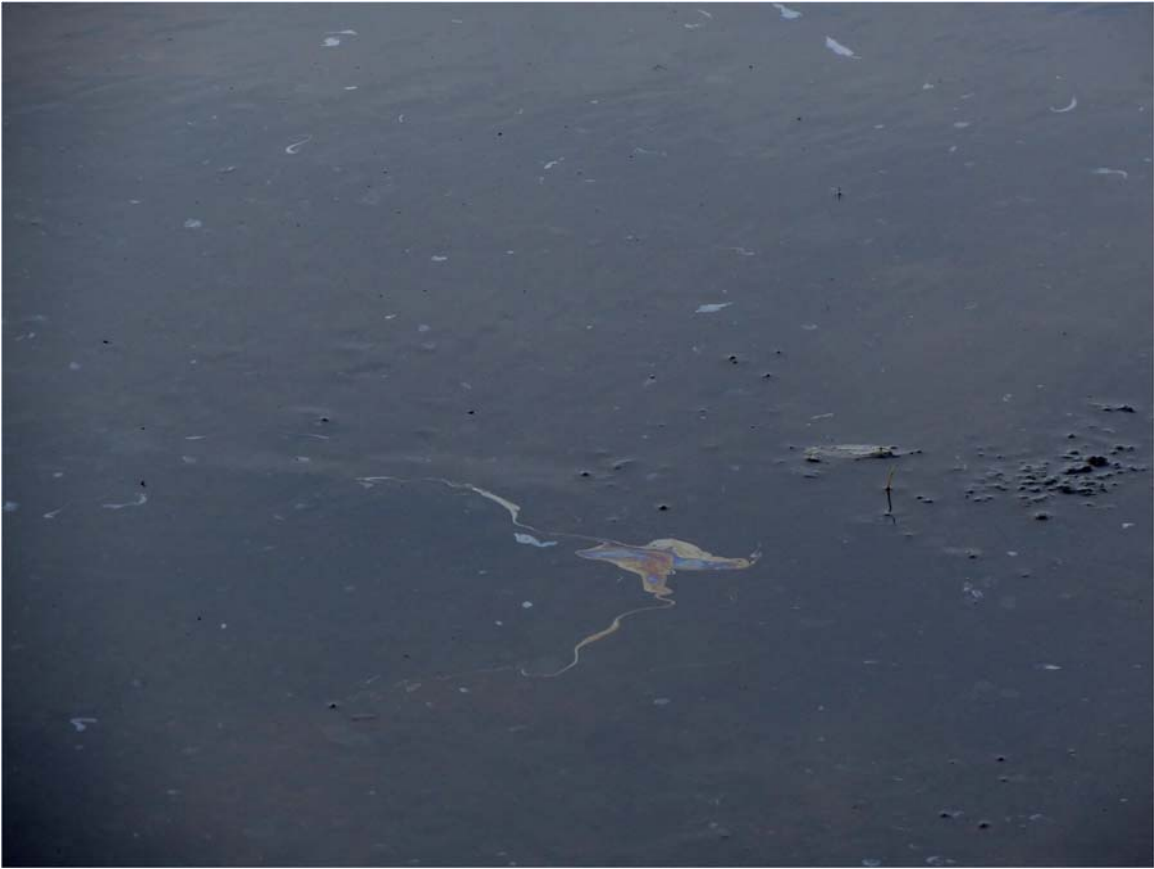
15. North Mill Pond observed sheen.

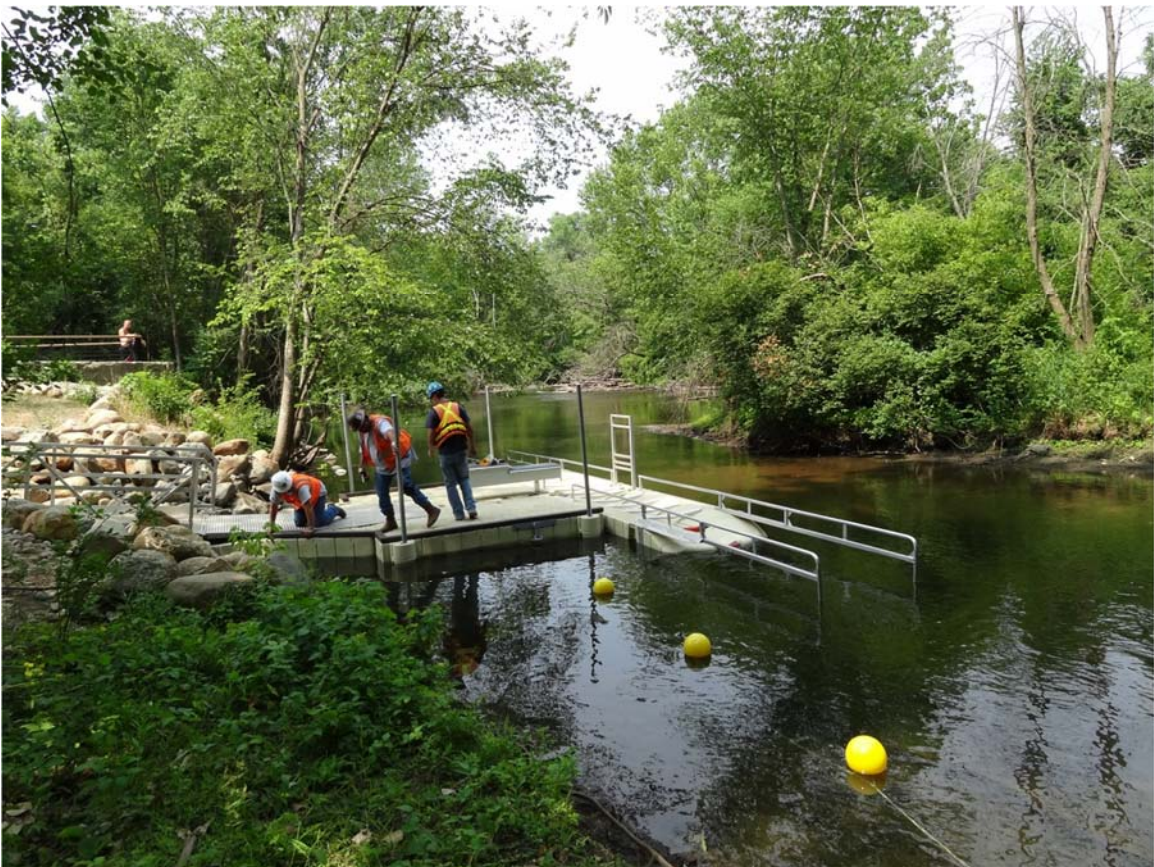
16. Paddler's Grove observed handicap boat launch being installed.

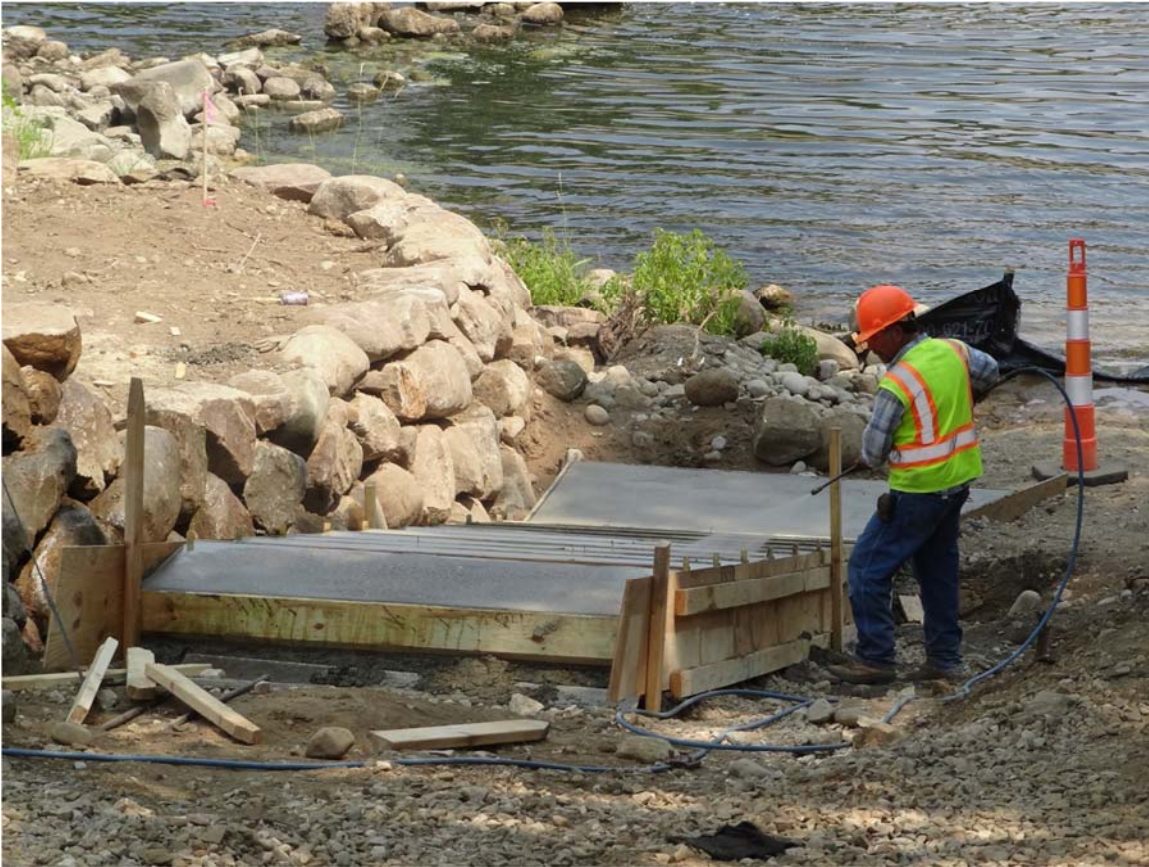
17. Ceresco Dam portage below the dam observed concrete work.

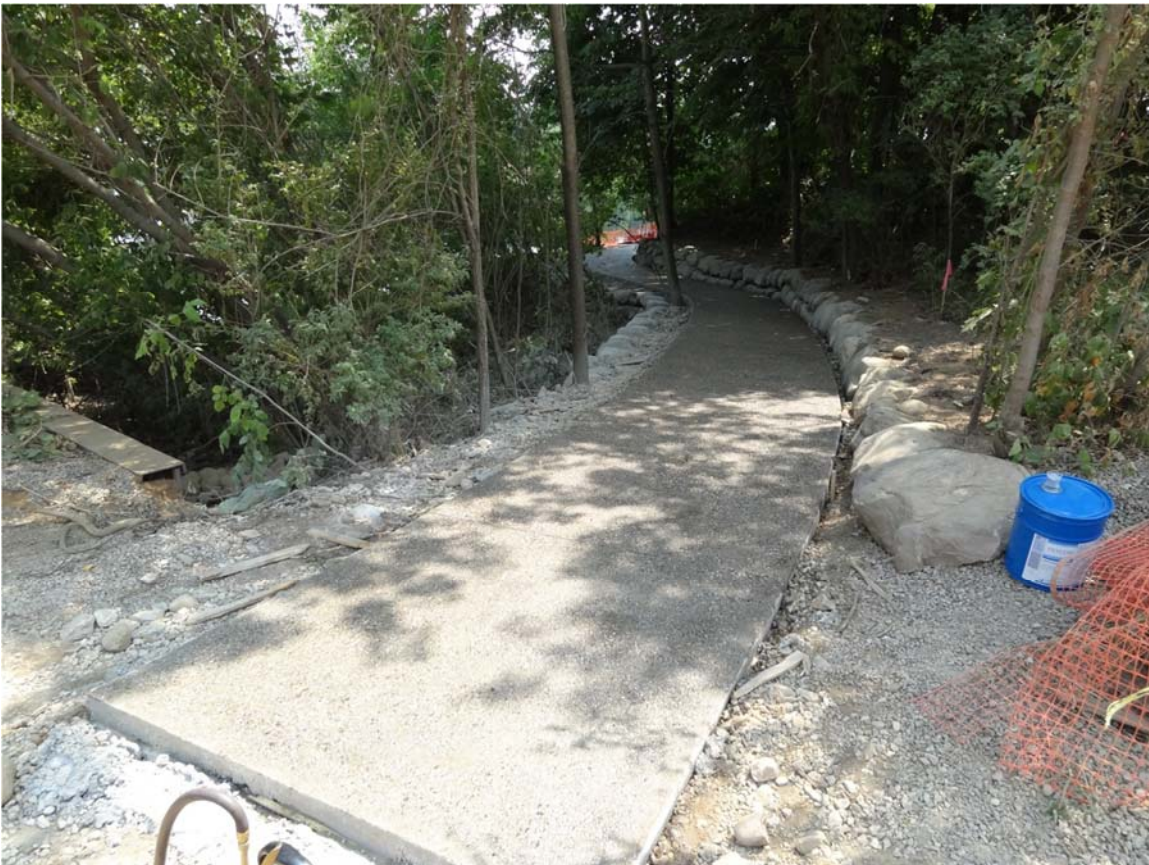
18. Ceresco Dam portage above the dam observed concrete sidewalk installed.

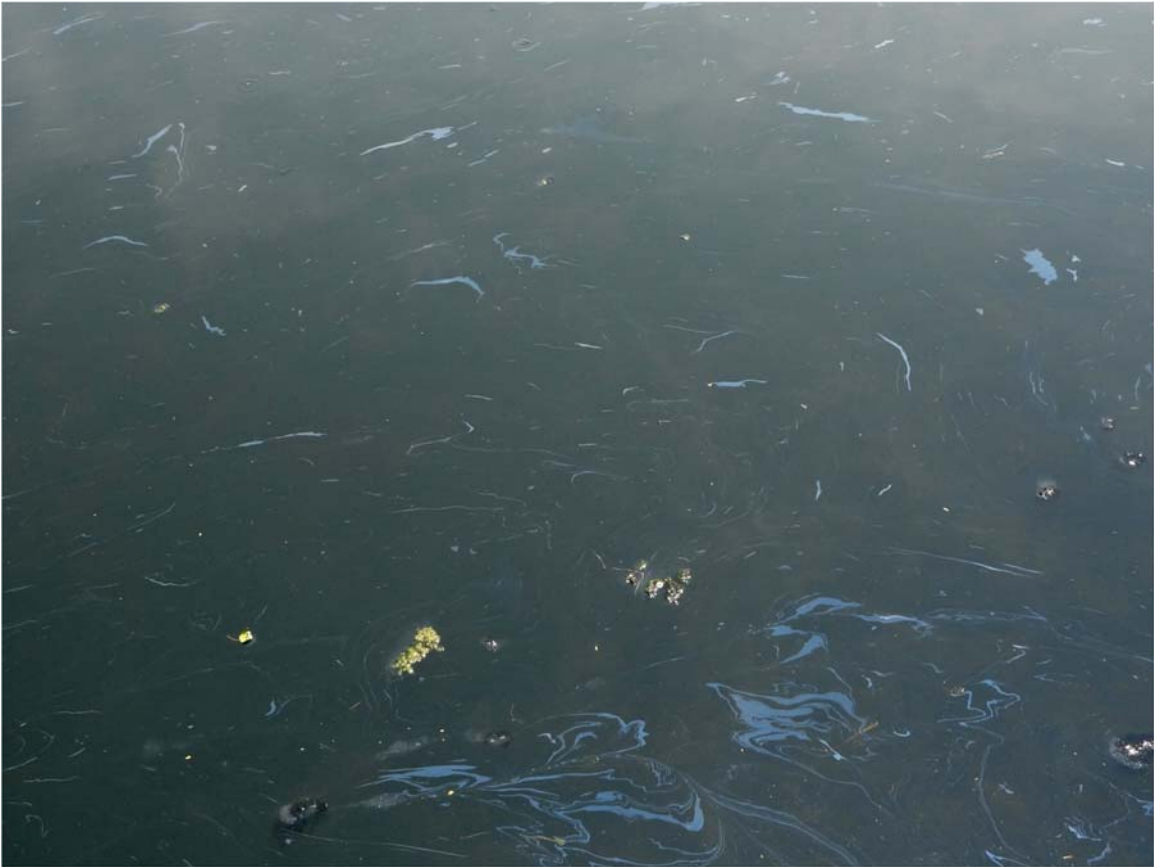
19. Ceresco Dam sheen observed.

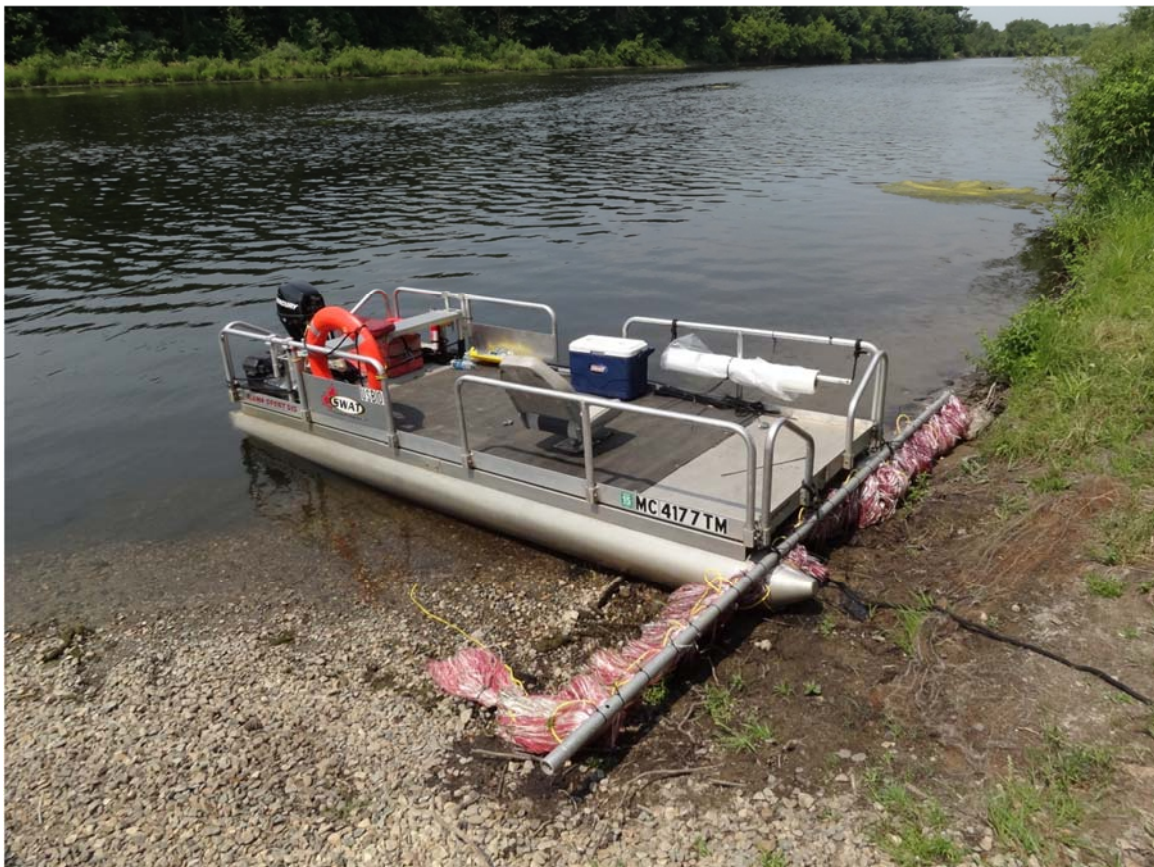
20. Sheen sweep boat observed at C0.4 boat launch.
